COMPLIANCE EVALUATION INSPECTION REPORT

INSTALLATION NAME: Scott Plating, Incorporated

DATE OF INSPECTION: August 15, 2012

INSTALLATION NAME: Scott Plating, Incorporated
EPA ID NO.: ILD056629629
LOCATION ADDRESS: 8034 North Central Park Avenue
Skokie, Illinois 60076
NAICS CODE: 332813, Electroplating, Plating, Polishing, Anodizing and
Coloring
RCRA CLASSIFICATON: Small Quantity Generator
DATE OF INSPECTION: January 31, 2013
EPA INSPECTOR: Robert Smith, LPG

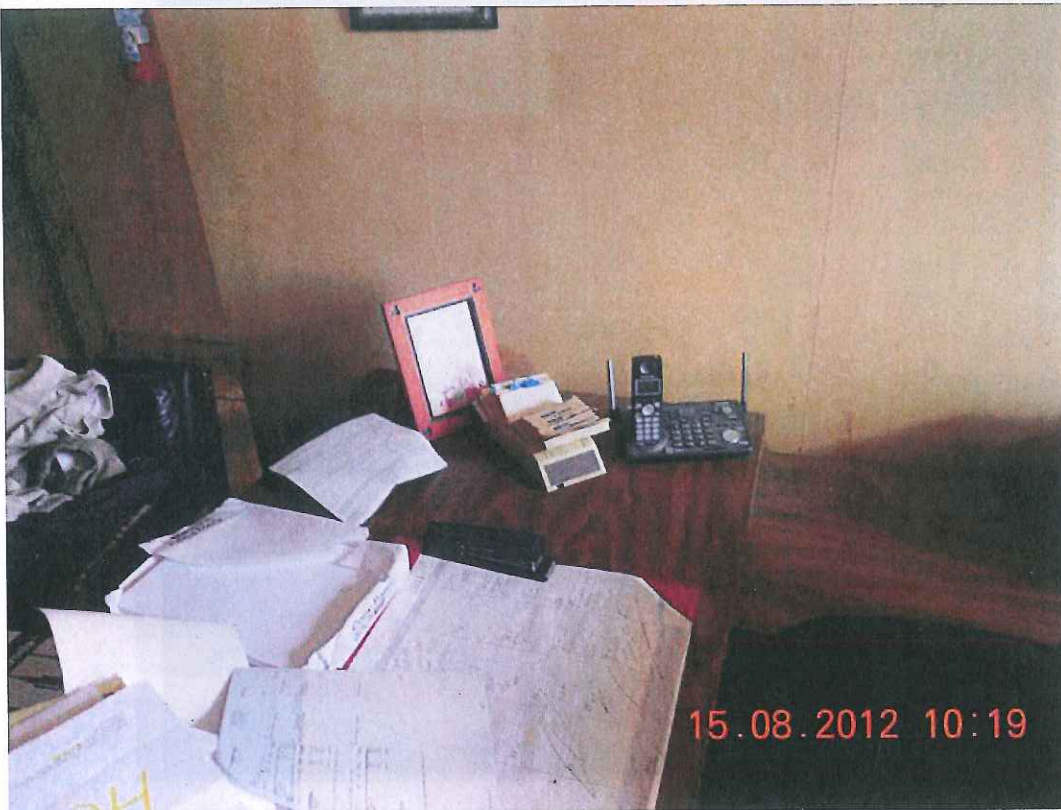
Facility: Scott Plating, ILD056629629
Location: 8034 North Central Park Avenue, Skokie, Illinois
Date: August 15, 2012
Photographer: Robert Dean Smith, LPG
Camera: Nikon Coolpix, 12.0 megapixels
Description: Photograph 1: Office on the second floor of the Scott Plating facility. I was not able to find a list of emergency contacts at or near the telephone in this photograph. I did not check the rolodex.

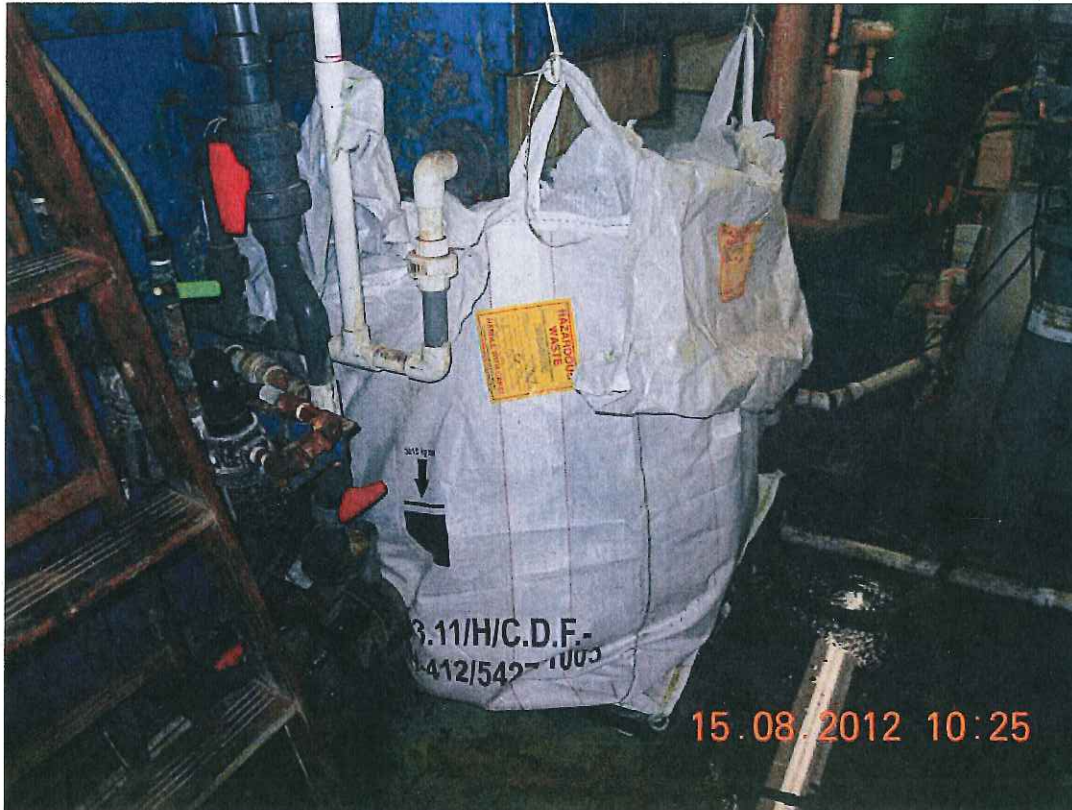
Facility: Scott Plating, ILD056629629
Location: 8034 North Central Park Avenue, Skokie, Illinois
Date: August 15, 2012
Photographer: Robert Dean Smith, LPG
Camera: Nikon Coolpix, 12.0 megapixels
Description: Photograph 2: Supersack under the filter press. The supersack has a hazardous waste label.

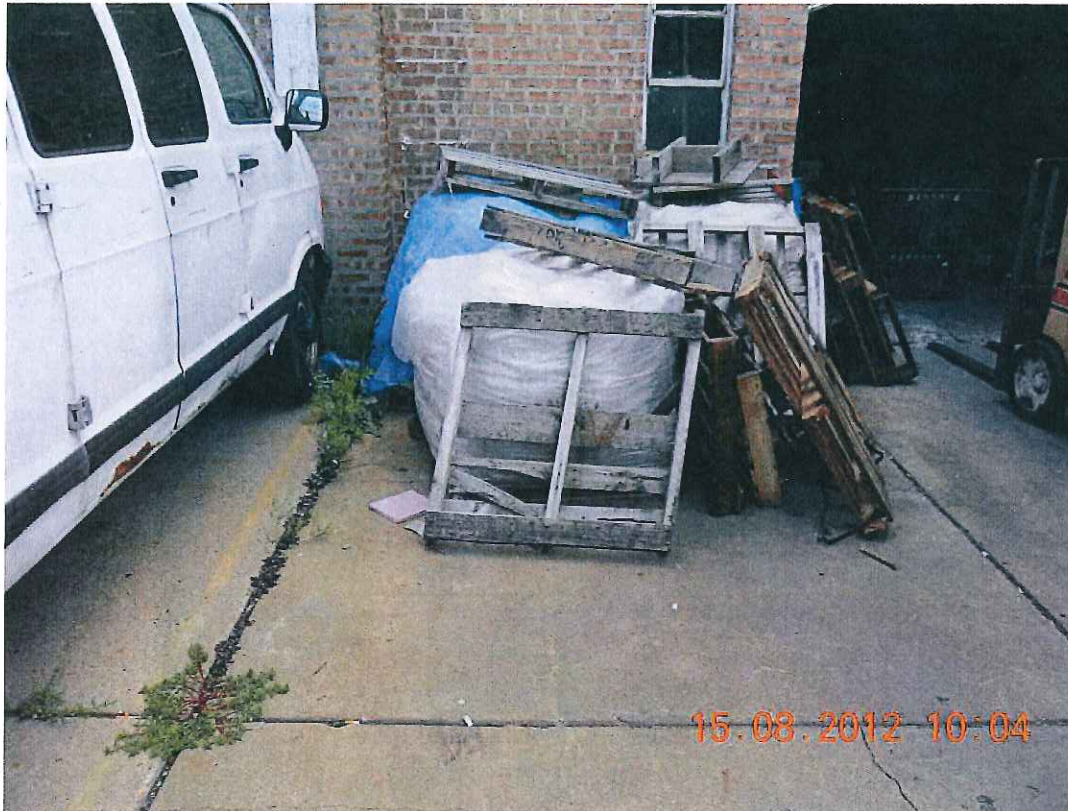
Facility: Scott Plating, ILD056629629
Location: 8034 North Central Park Avenue, Skokie, Illinois
Date: August 15, 2012
Photographer: Robert Dean Smith, LPG
Camera: Nikon Coolpix, 12.0 megapixels
Description: Photograph 4. Rear of the Scott Plating building. Scott is storing three supersacks of F006 hazardous waste outside its facility within the confines of the stacked pallets seen here. The supersacks are covered by either clear or blue visqueen. The hazardous waste labels are affixed to the supersacks; however, the ink has either run or cannot be read through the visqueen.

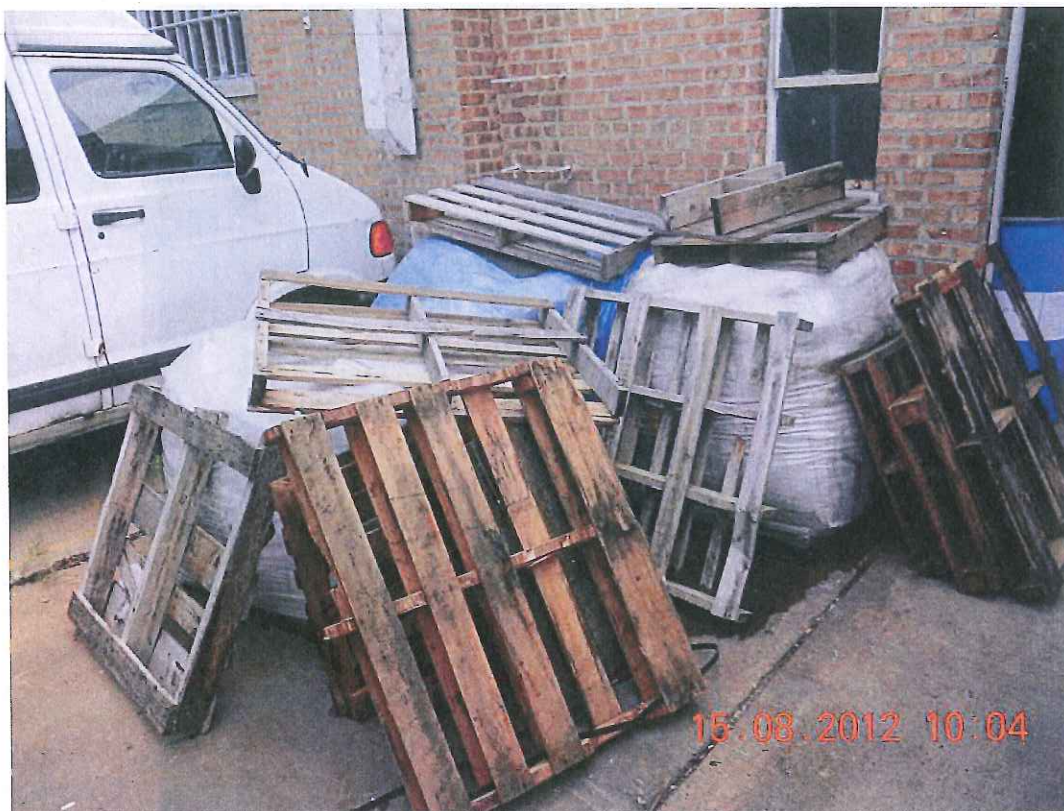
Facility: Scott Plating, ILD056629629
Location: 8034 North Central Park Avenue, Skokie, Illinois
Date: August 15, 2012
Photographer: Robert Dean Smith, LPG
Camera: Nikon Coolpix, 12.0 megapixels
Description: Photograph 4; Close up of the three hazardous waste supersacks in storage behind the Scott Plating facility.

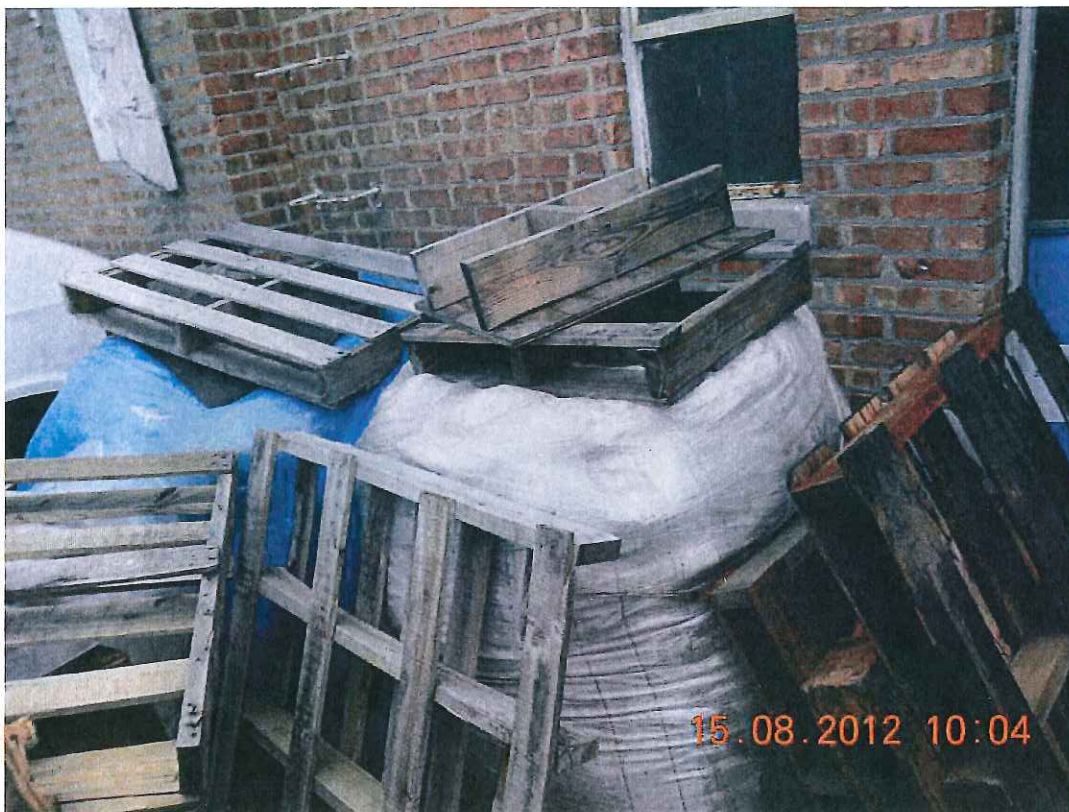
Facility: Scott Plating, ILD056629629
Location: 8034 North Central Park Avenue, Skokie, Illinois
Date: August 15, 2012
Photographer: Robert Dean Smith, LPG
Camera: Nikon Coolpix, 12.0 megapixels
Description: Photograph 5: Close up of the supersacks containing F006 hazardous waste in storage outside and in the rear of the Scott building.

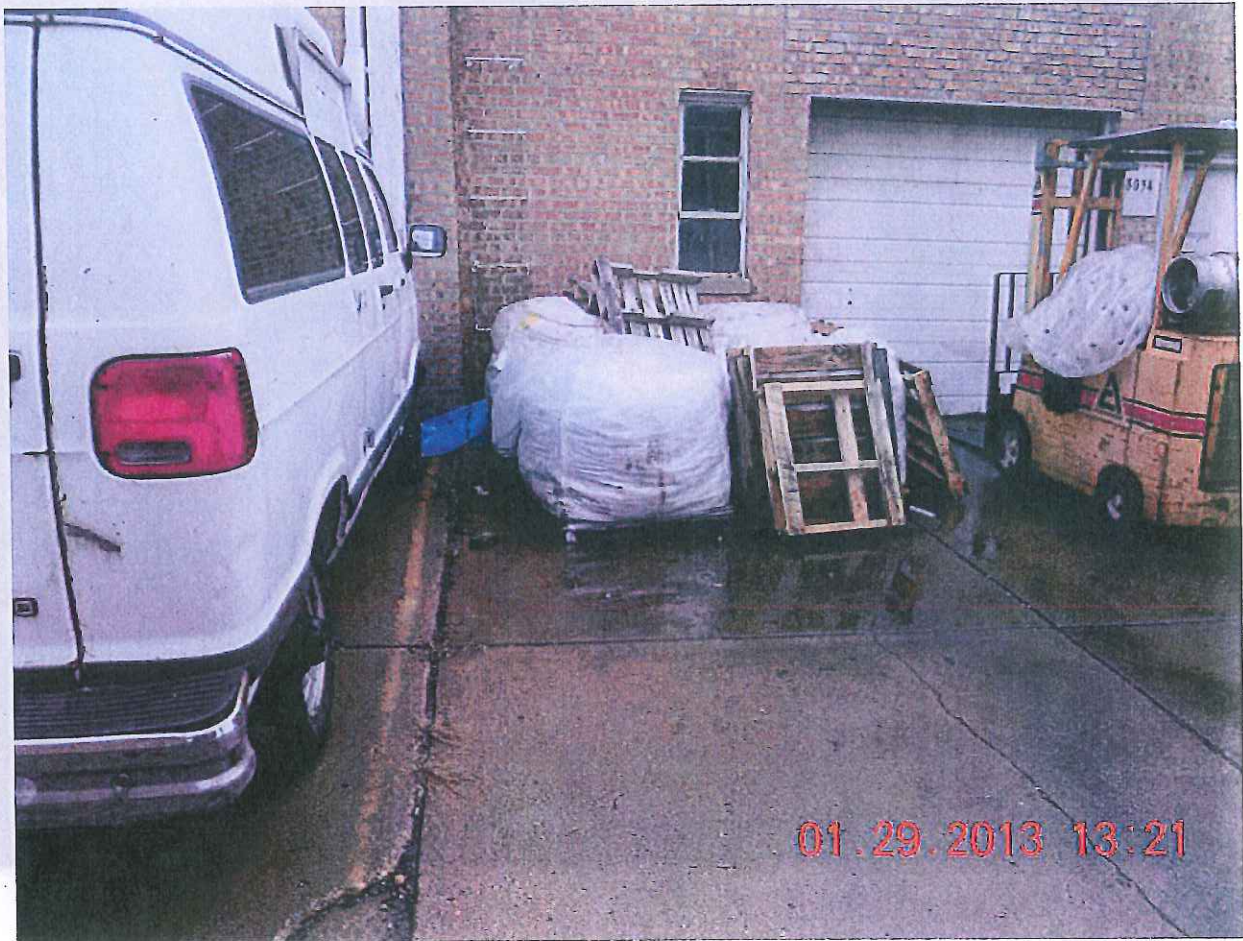
Photograph 1: Four supersacks of hazardous waste in storage behind the facility. The supersacks are covered with visqueen and it is difficult to see or read hazardous waste stickers.

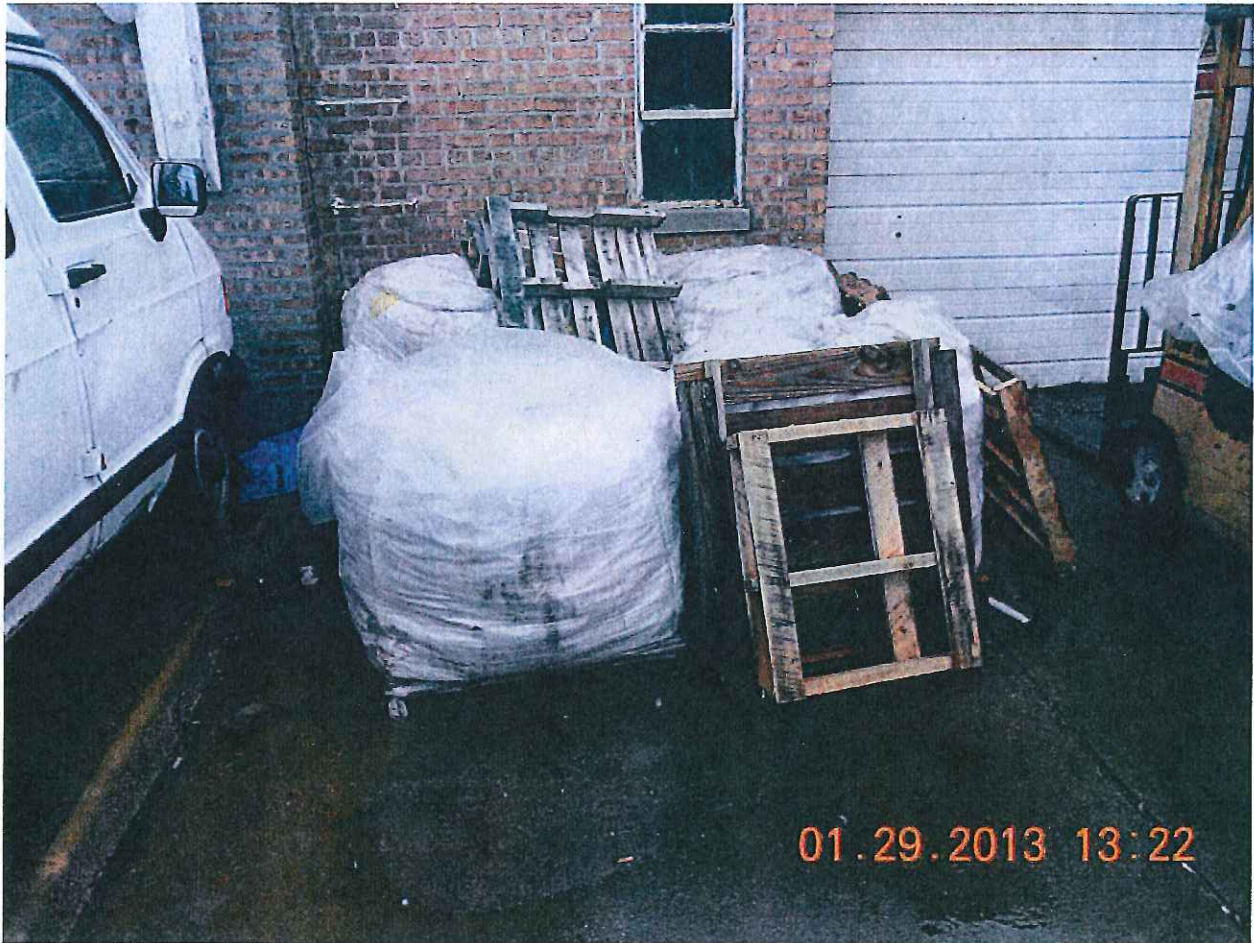
Photograph 2: Four supersacks of hazardous waste in storage behind the facility. The supersacks are covered with visqueen and it is difficult to see or read hazardous waste stickers. Close up of photograph 1.
